## **ELDRIDGE ELECTRIC AND WATER UTILITY BOARD**

August 22, 2023  
5:00 pm  
City Hall, 305 N. 3<sup>rd</sup> Street

7. Water Department – Brock Kroeger
  - A. **Water Tower Reports**
  - B. Department Update

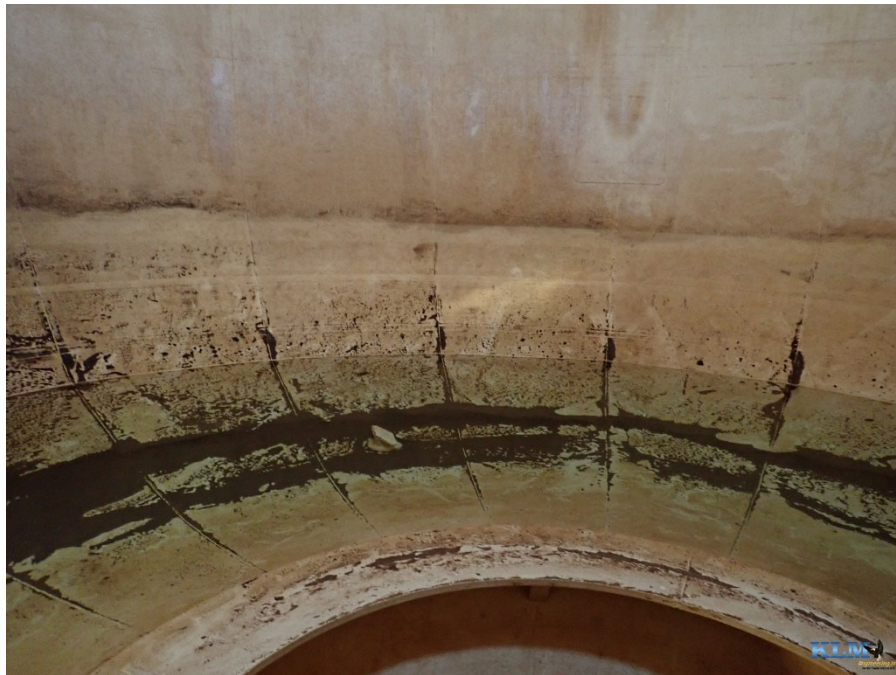
Photo No. 13  
Bowl conditions prior to cleanout

The interior wet coating is in fair condition with greater than five percent visible coating failures above the high-water line (HWL) and approximately one percent coating failures below the HWL. Failures above the HWL consist of corrosion along unwelded roof plate overlap joints, unwelded finial vent and wet access manway collars, intermittently welded joints between the rafters and the roof plates, and unwelded overlap joint between the roof plates and upper torus. Failures below the HWL consist of pinhole corrosion along the intermittently welded shell stiffener ring and isolated pinhole corrosion at random locations on the bowl and riser cone. Dark brown and rust colored staining is very pronounced along the HWL but still present on most of the surfaces below the water level. A minor amount of sediment accumulation was present and removed from the bowl area during the cleanout. See photos in Appendix A.

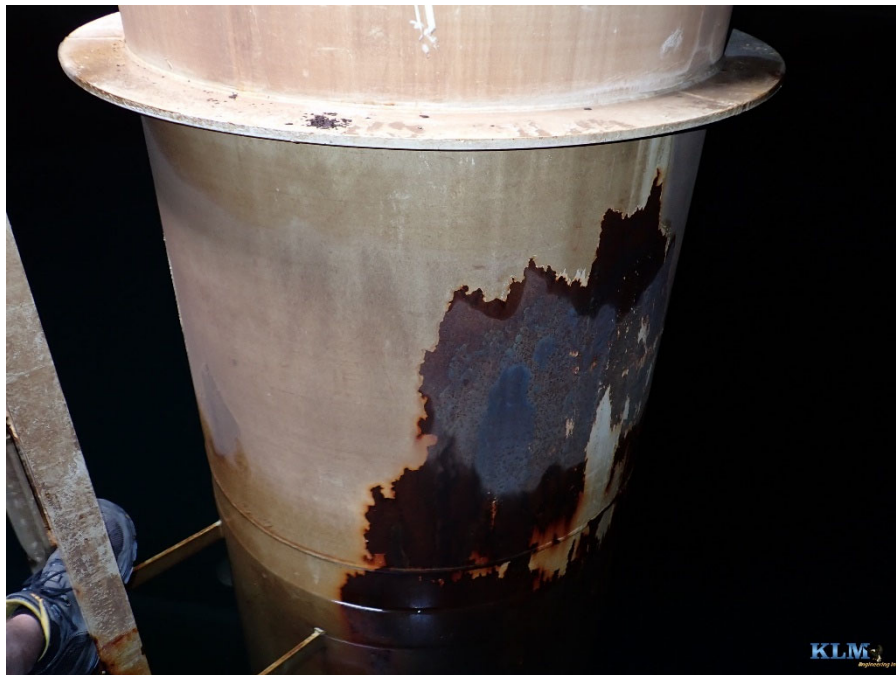
Photo No. 15  
Drywell tube with overflow pipe inlet visible  
Advanced corrosion visible

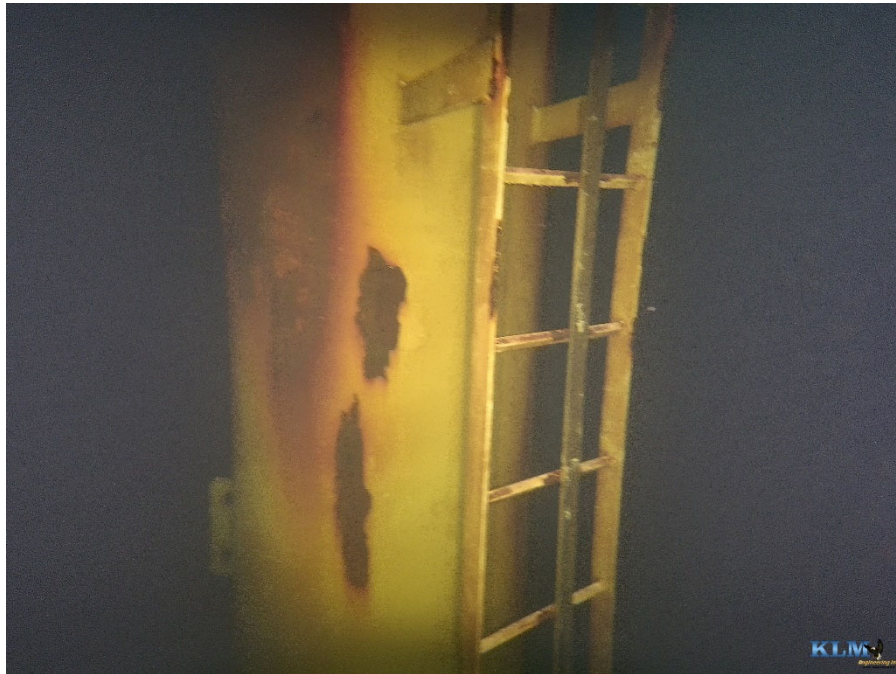
Photo No. 16  
Drywell tube above HWL conditions  
Widespread corrosion visible

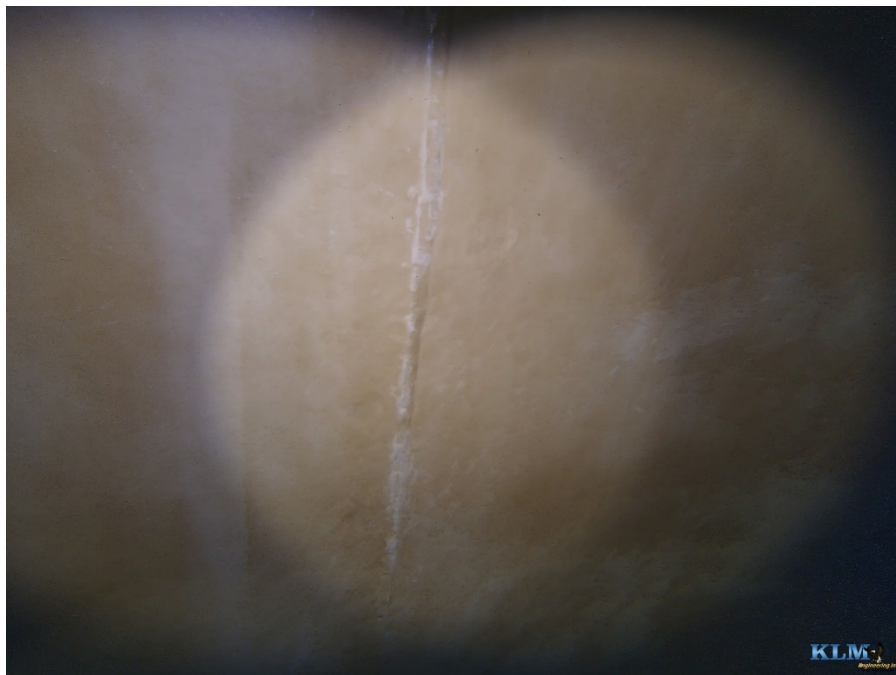
Photo No. 19  
Conditions of coating failure on drywell tube

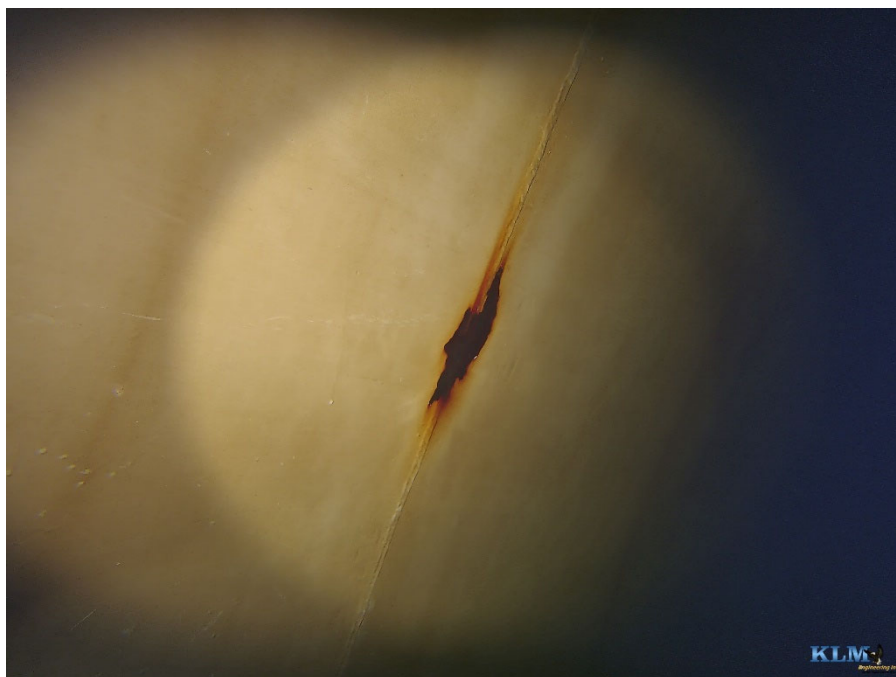
Photo No. 21  
Coating failure on shell

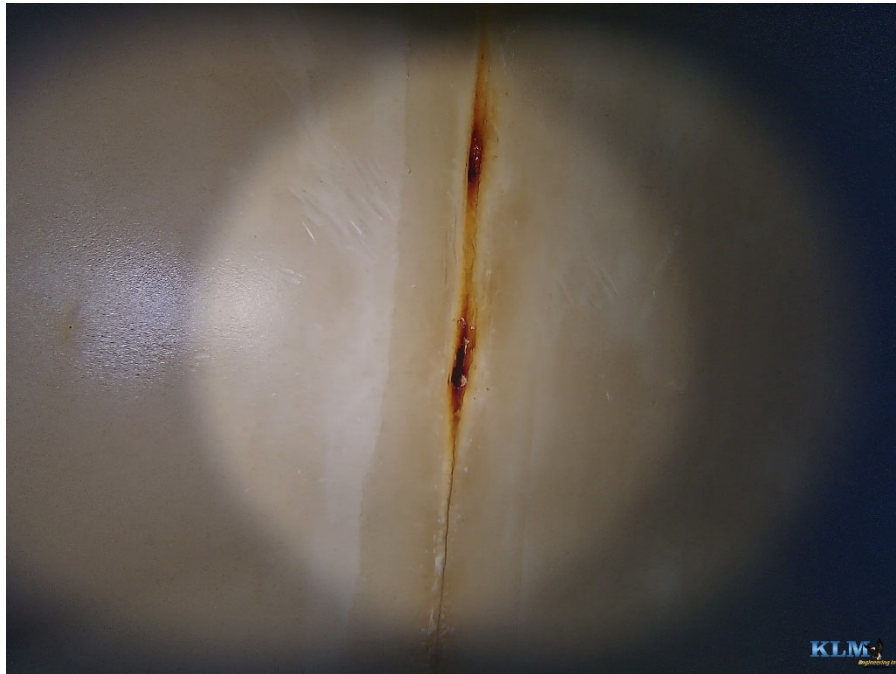
Photo No. 22  
Coating failure on shell

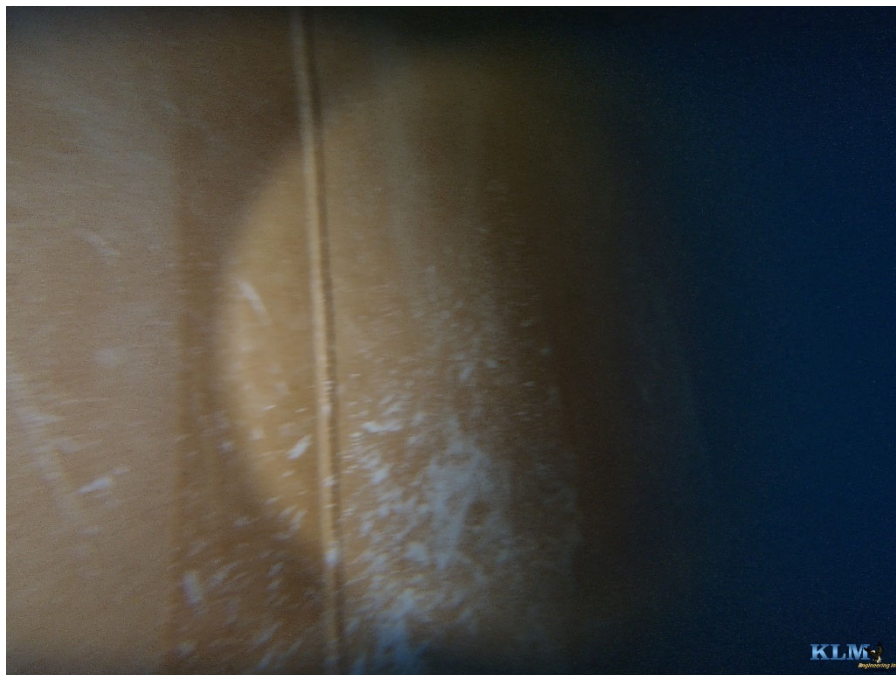
Photo No. 23  
Coating failures along weld seam

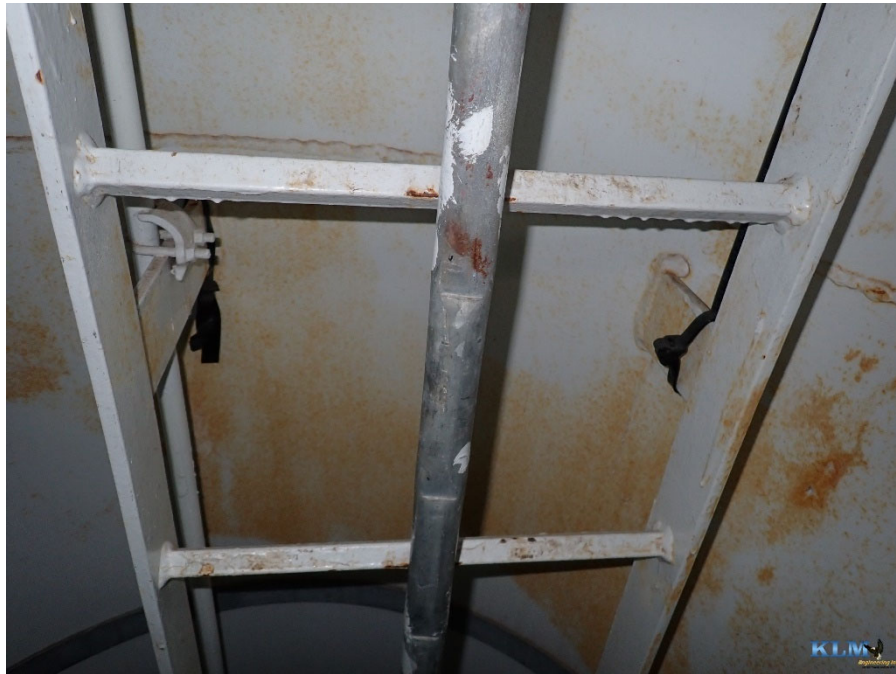
Photo No. 36  
Coating failures visible in drywell tube

**4.2.1** Replace the pipe style safety climb device with easier to operate cable-style safety climb devices on all ladders in the pedestal. See photos 35 through 42 and 46 through 49.

**4.2.4** Install welded cable stand-offs inside the drywell tube and pedestal for attachment of electrical and coaxial cables. The existing expansion and U-bolt brackets tend to damage the coatings without additional protection and collect condensation. See photos 35 through 53.

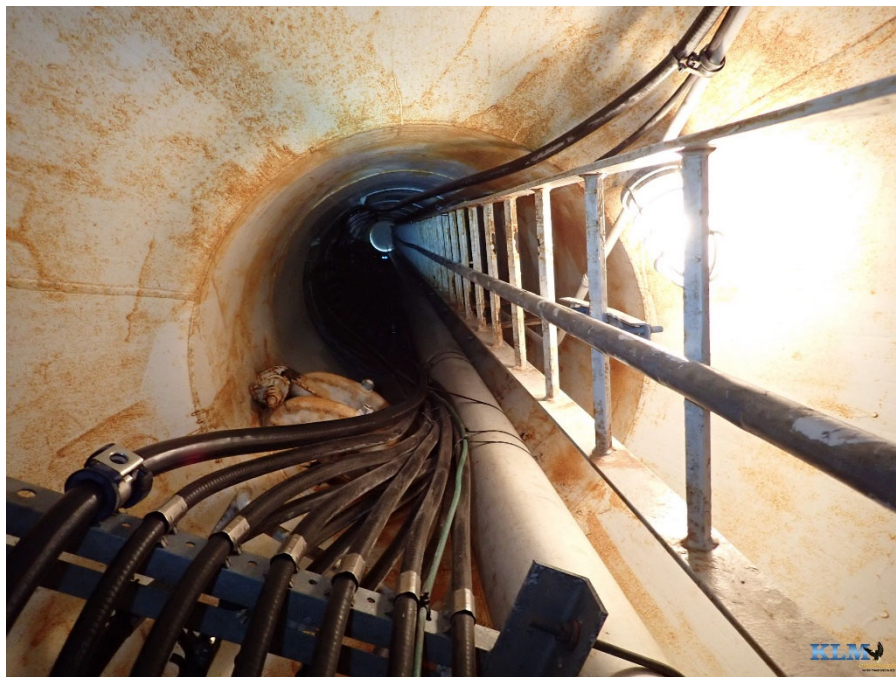
Photo No. 39  
Coating failures within base of drywell tube
