## **ELDRIDGE ELECTRIC AND WATER UTILITY BOARD**

July 7<sup>th</sup>, 2026 – 5:00 pm  
City Hall, 305 N. 3<sup>rd</sup> Street

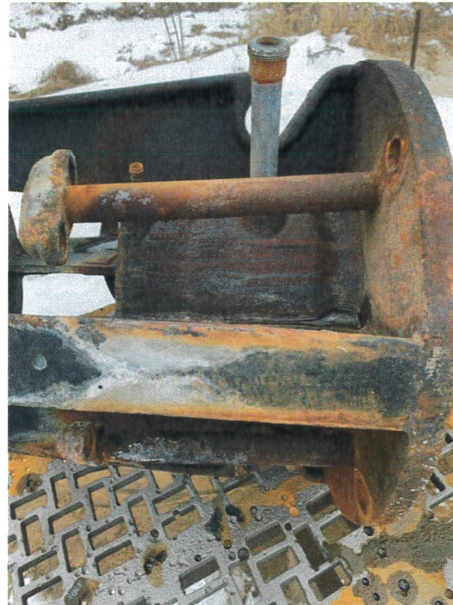
Discharge base

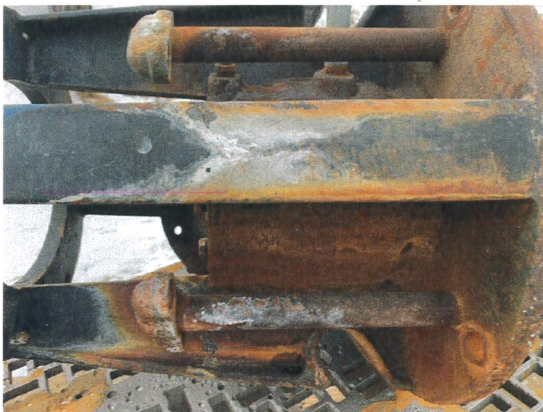
Discharge base with breather ports

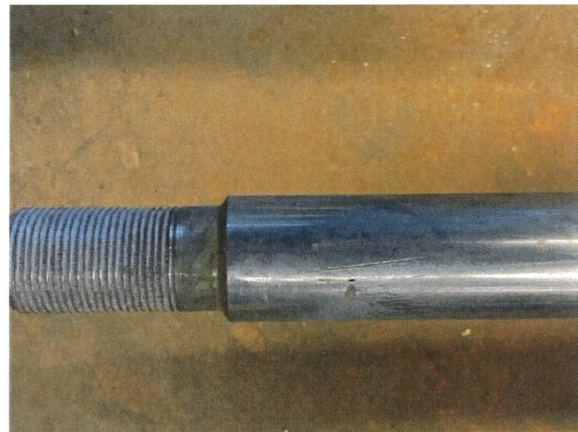
Bowl shaft fracture

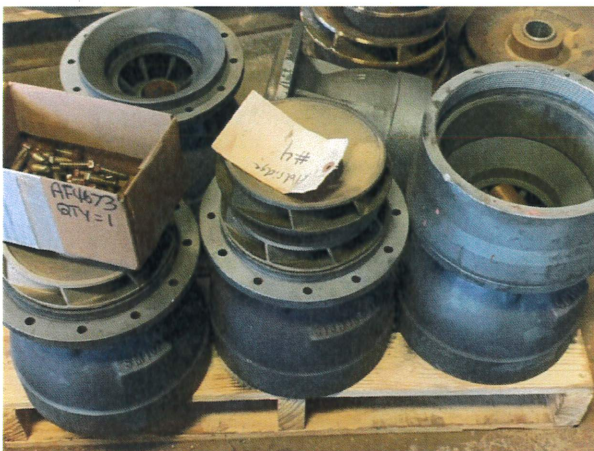
Intermediate bowls and impellers

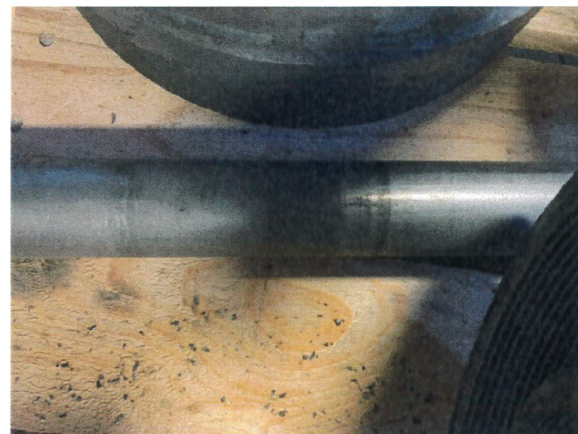
Bowl shaft with bearing surface wear

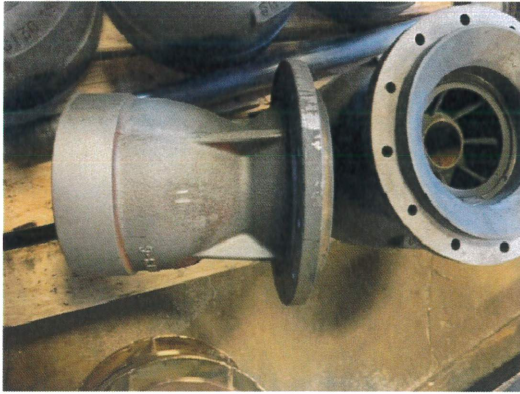
Suction case

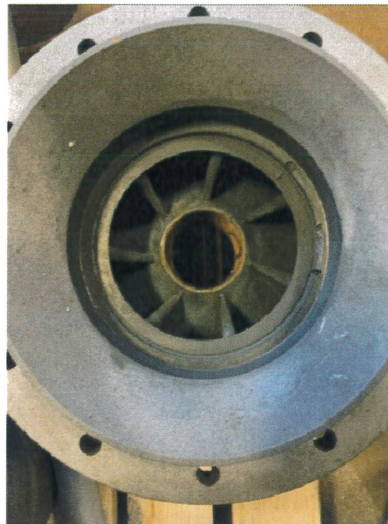
Intermediate bowl and bowl bearing

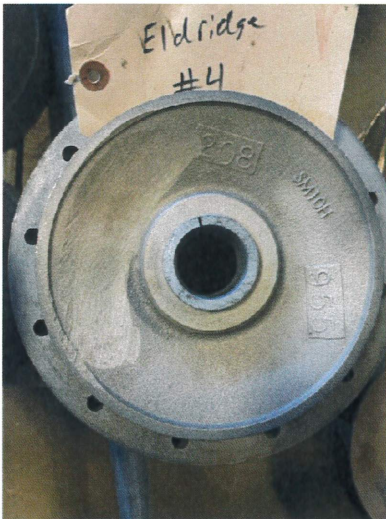
Bronze impeller

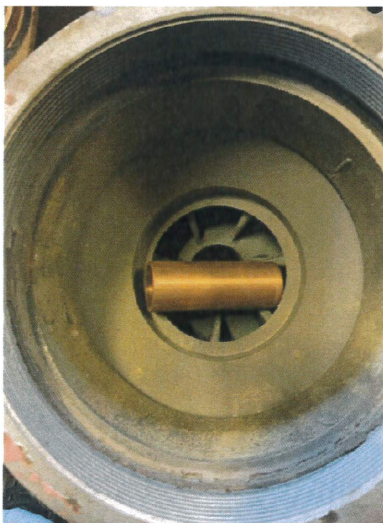
Discharge bowl with removed bowl bearing

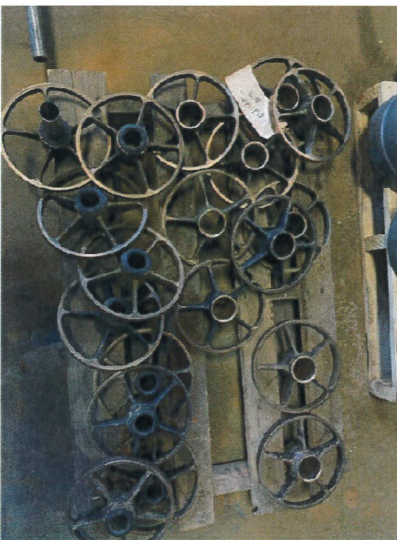
Column spiders

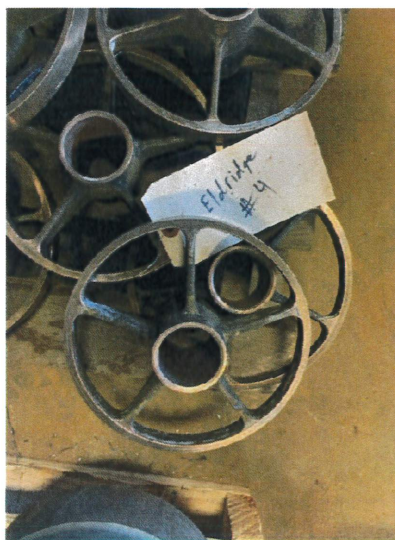
Column spiders with bearing inserts removed
