## **ELDRIDGE ELECTRIC AND WATER UTILITY BOARD**

August 22, 2023  
5:00 pm  
City Hall, 305 N. 3<sup>rd</sup> Street

7. Water Department – Brock Kroeger
  - A. **Water Tower Reports**
  - B. Department Update

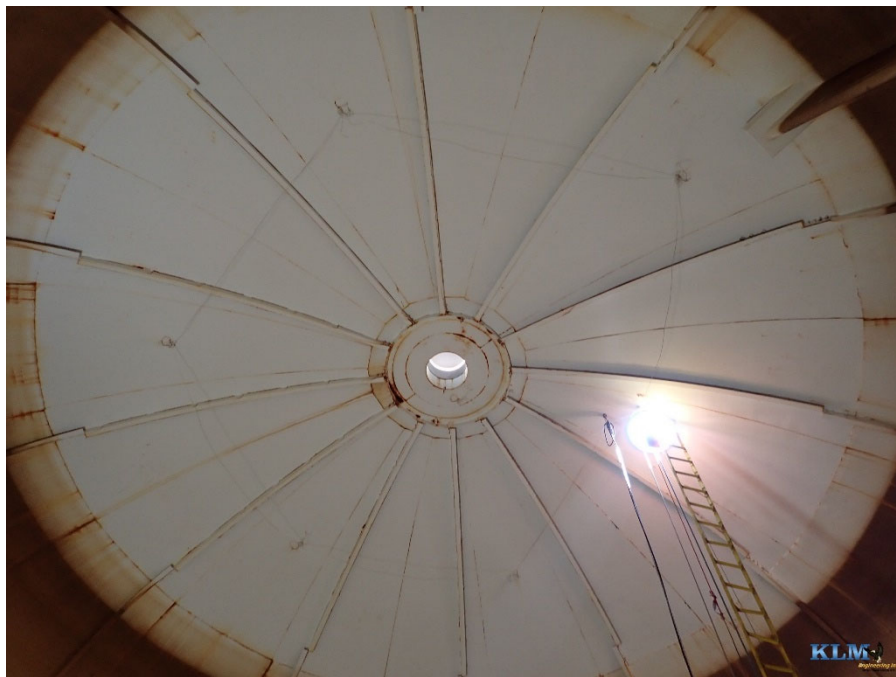
Photo No. 2  
View of interior roof

**4.1.1** Seal weld miscellaneous roof and upper torus joints to prevent rust streaking and corrosion in areas inaccessible to paint. See photos 2 through 7.

**4.1.2** Seal weld all bolted roof-framing connections and remove all nuts and bolts after welding. Welding rafter connections are a standard in AWWA D100-11. See photos 2 through 7.

- 4.1.3** Seal weld the intermittently welded stiffener angles, shell stiffener ring, and support column stiffeners for compliance with AWWA D100-11. See photos 2 through 10.
- 4.1.4** Install a welded-in-place grating at the top of the wet riser. This grating should be capable of supporting a painter's rigging. Having this arrangement facilitates future maintenance and prevents a fall down the wet riser. See photo 19.
- 4.1.5** Replace the gasket on the wet riser manway. See photos 21 and 42.
- 4.1.6** Grind off all weld spatter and erection scab marks for compliance with AWWA D100-11.

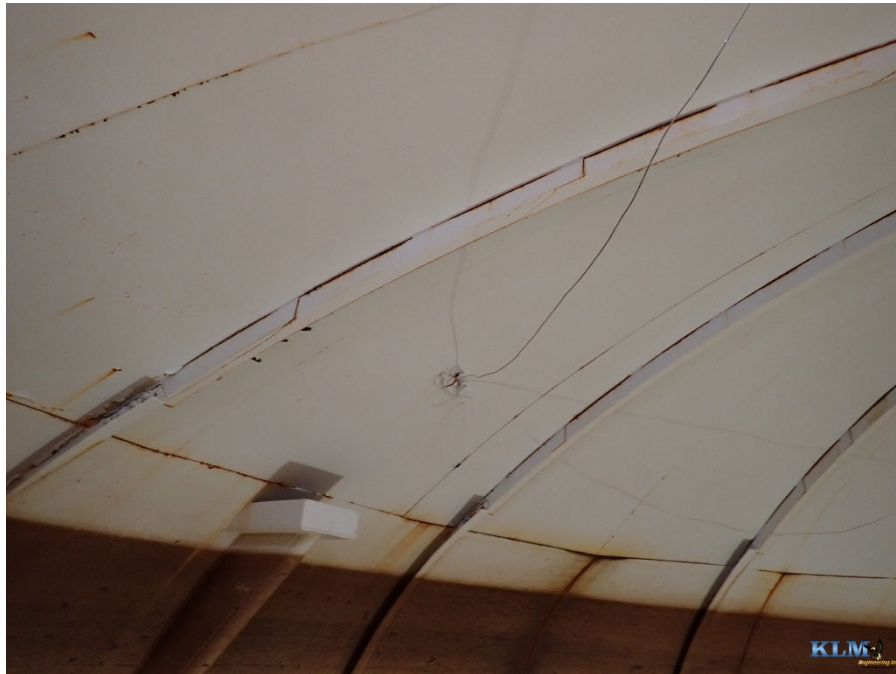
Photo No. 5  
Roof and upper torus

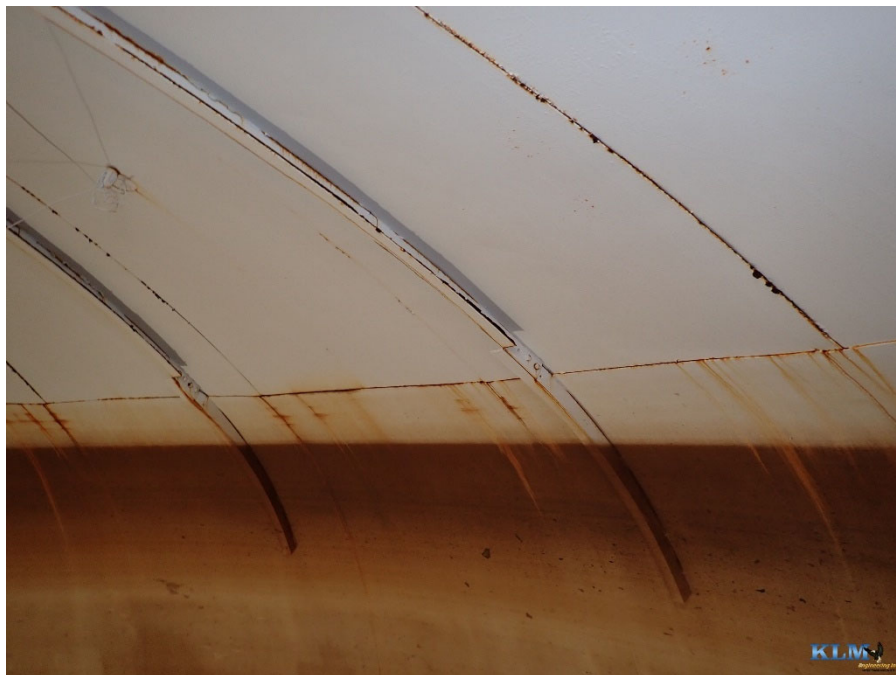
Photo No. 6  
Roof and upper torus

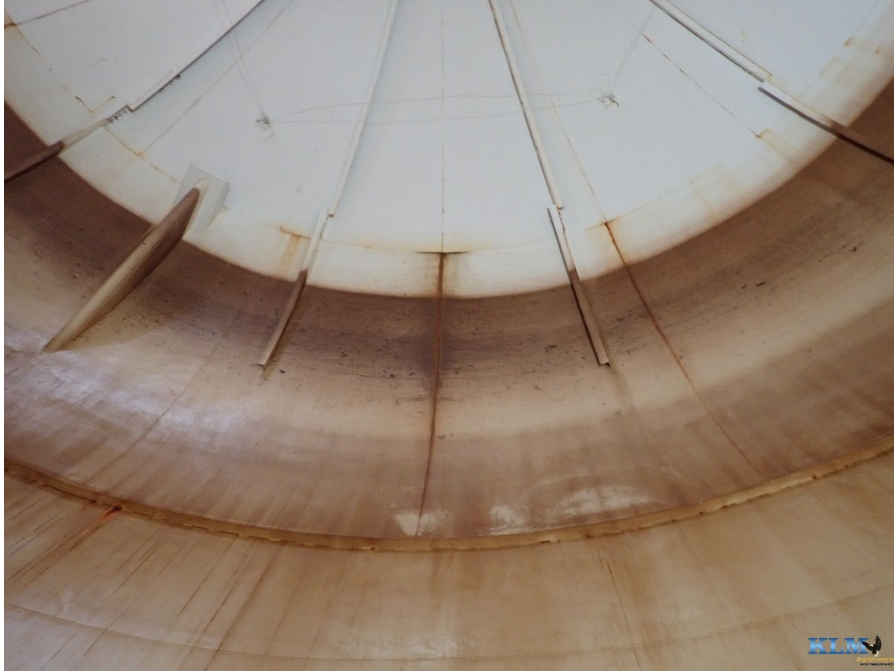
Photo No. 7  
Upper torus and shell conditions

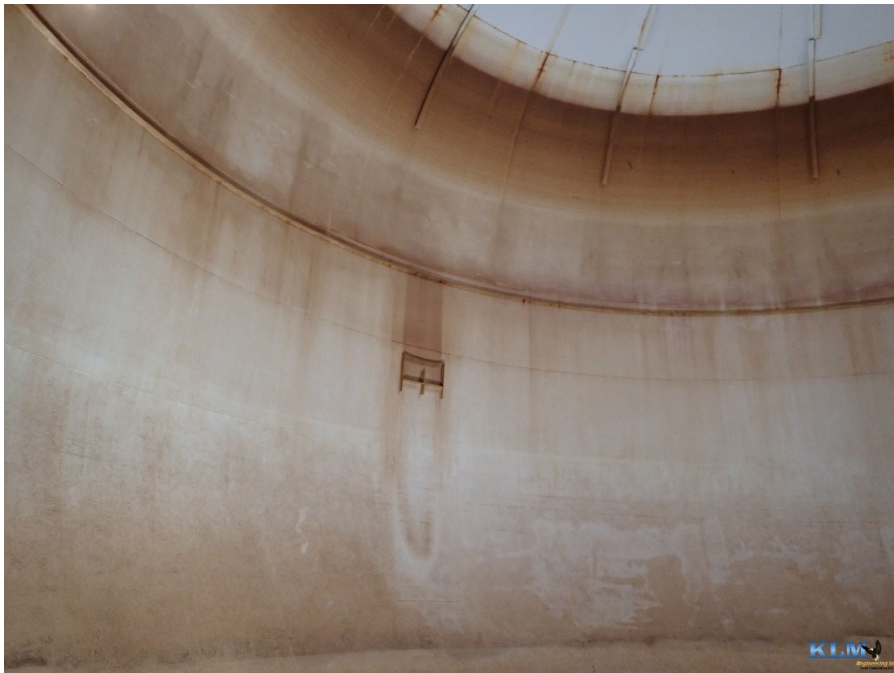
Photo No. 8  
Shell coating conditions

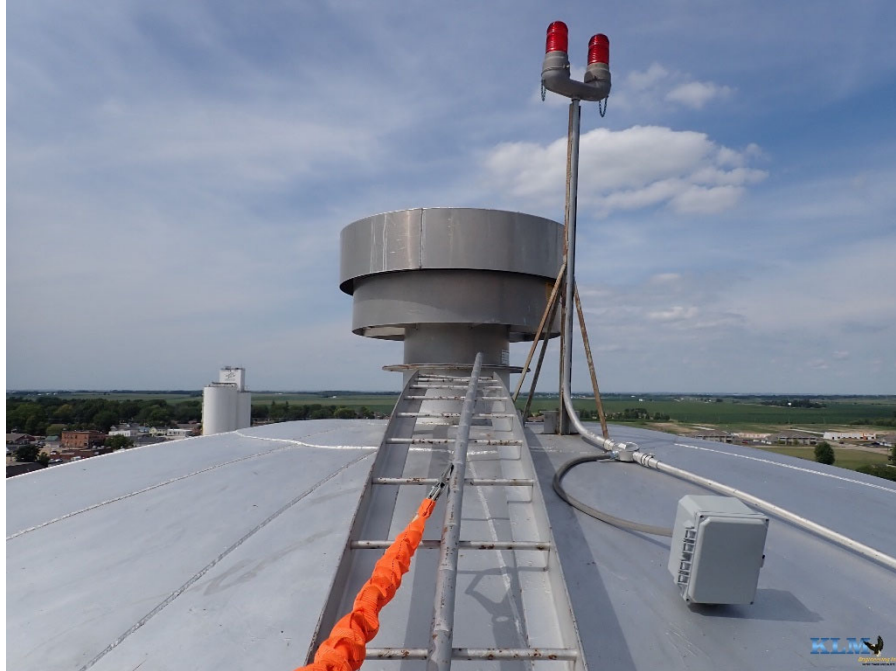
- 4.2.3** Remove the existing aviation light and install a new LED aviation light and bracket on the new roof handrail. See photo 23.
- 4.2.4** Replace the existing ladders with new ladders conforming to OSHA regulations. The existing ladders do not meet current OSHA rung width and ladder rail spacing requirements. Include installing cable style safety climbing devices on the new ladders. See photos 23, 29, 30, 39, and 41.

Photo No. 23  
View of roof  
Finial vent and aviation light visible

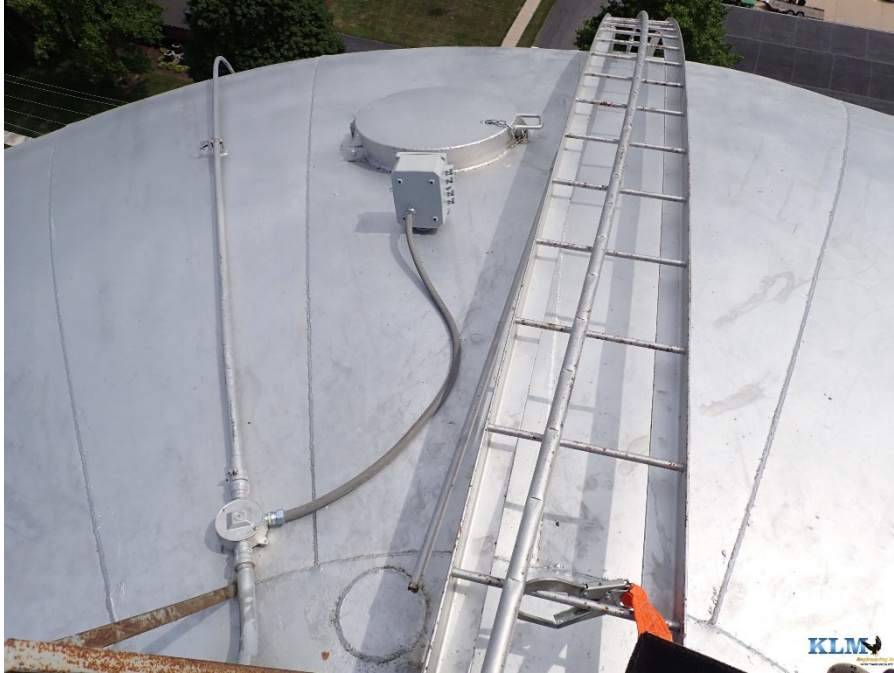
Photo No. 29  
Roof coating conditions

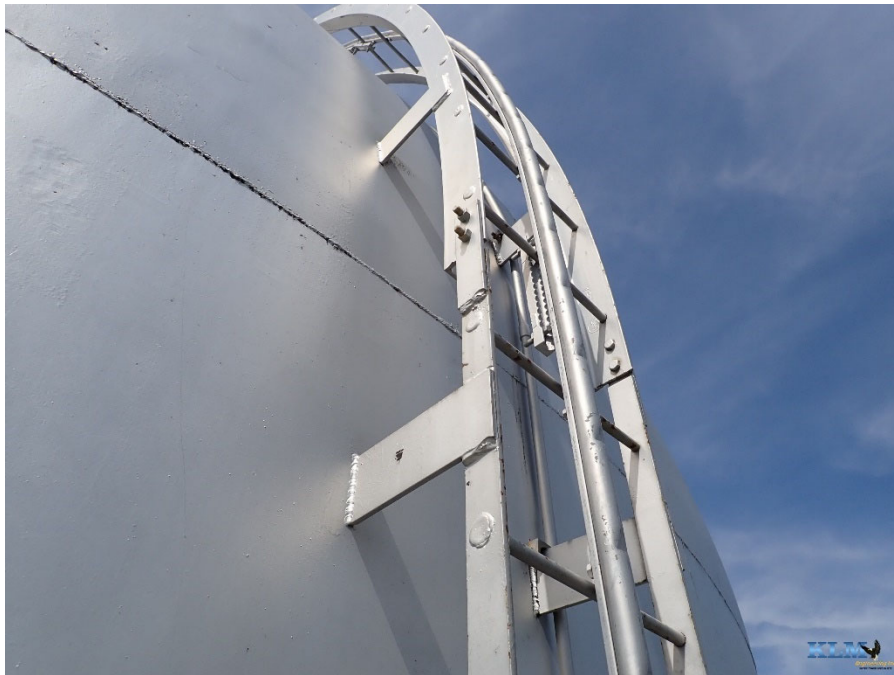
Photo No. 30  
Roof access ladder

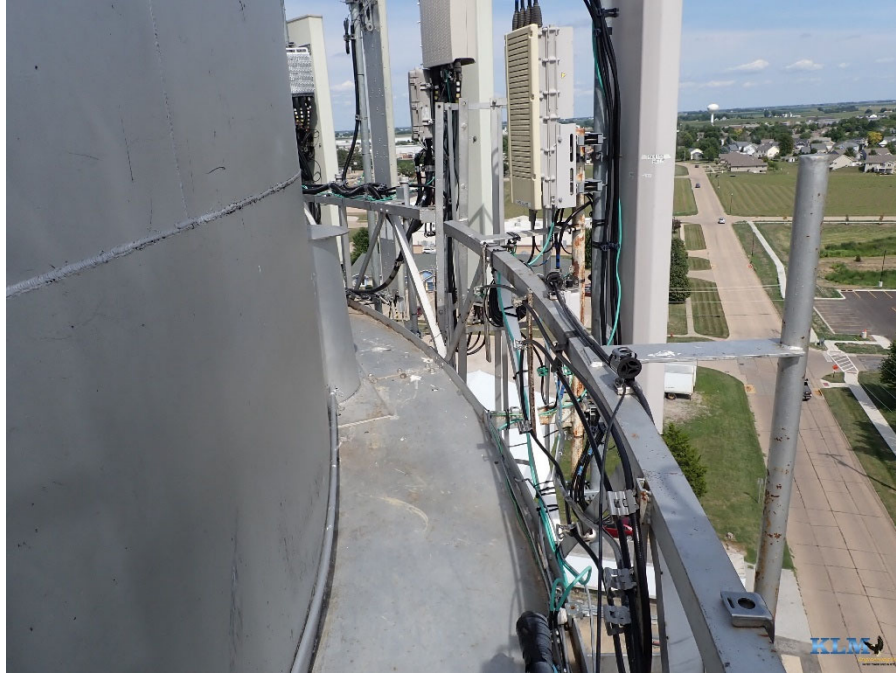
- 4.2.5** Install a mid-rail on the balcony handrail conforming to OSHA regulations. See photos 33 and 34.
- 4.2.6** Seal weld the intermittently welded seam between the topside of the balcony and the shell to conform to AWWA D100-11. See photos 35 and 36.

Photo No. 33  
Balcony platform and handrail

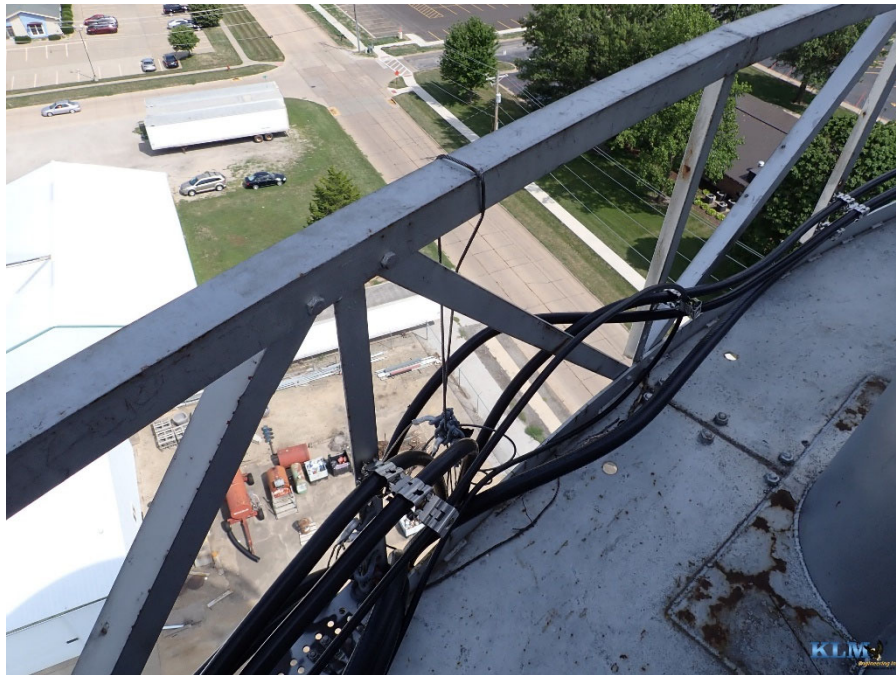
Photo No. 34  
Balcony platform and handrail

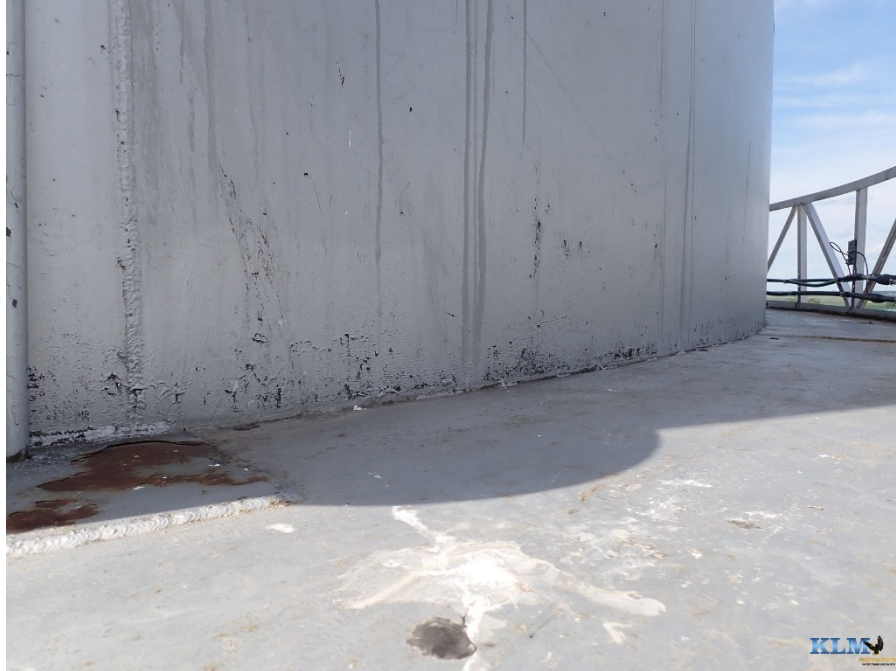
Photo No. 35  
Balcony platform conditions

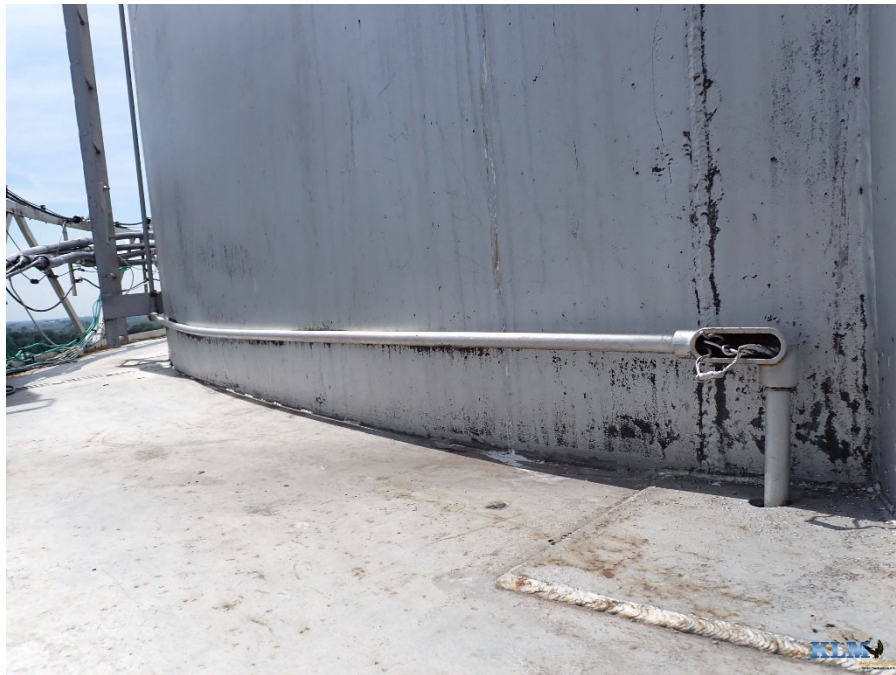
Photo No. 36  
Balcony platform conditions

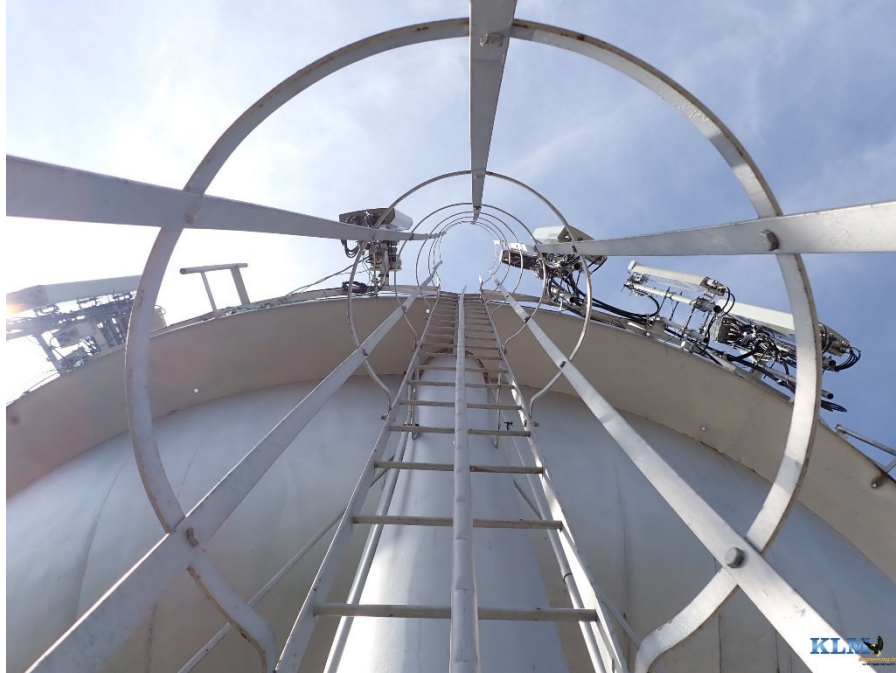
Photo No. 39  
Column access ladder

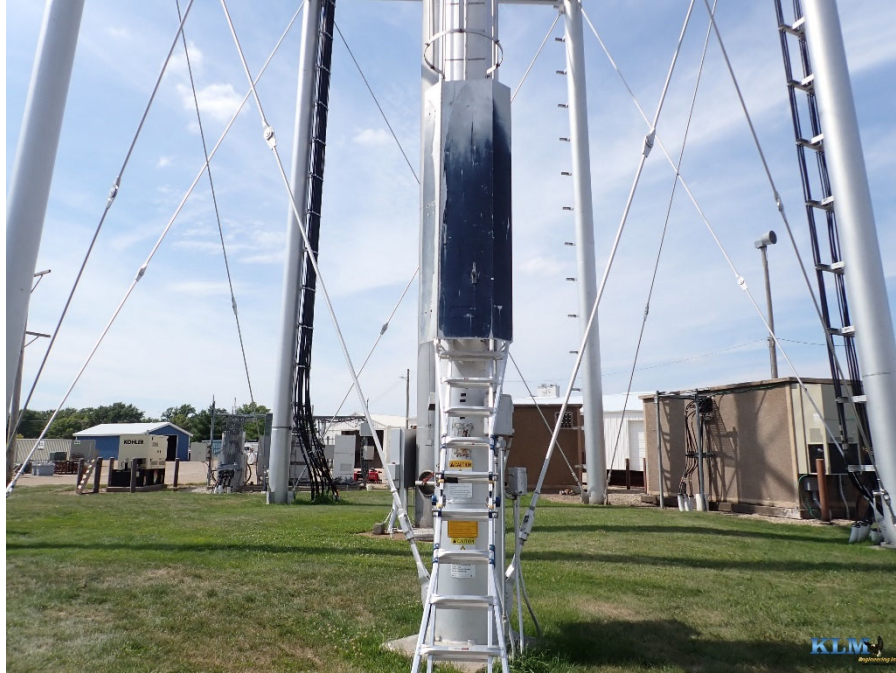
Photo No. 41  
Column access ladder at grade

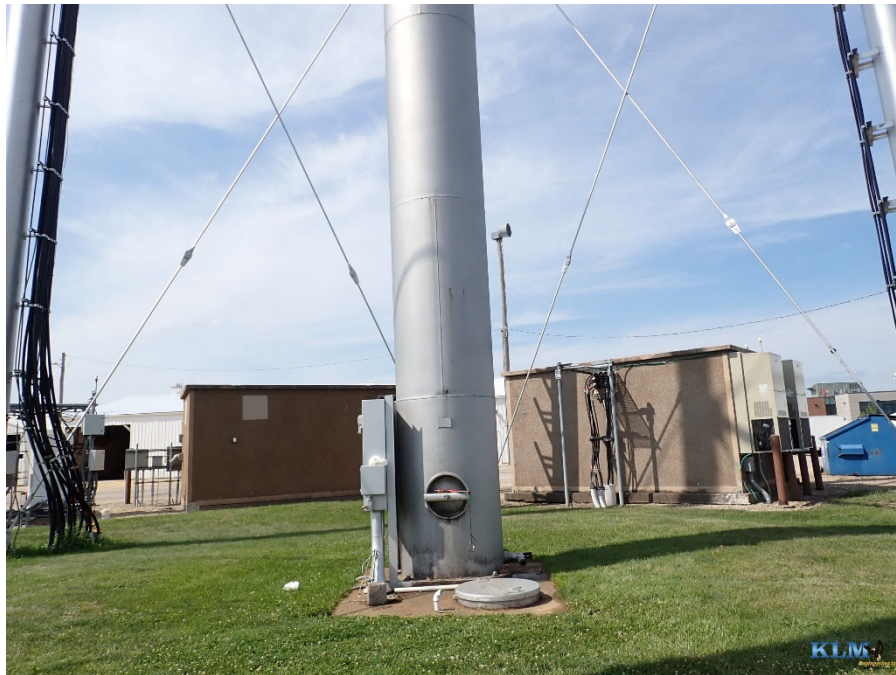
- 4.2.8** Install one additional pressure-style manway in the bottom section of the wet riser, 180 degrees from the existing manway, to improve ventilation during reconditioning and bring the tank into compliance with OSHA confined space entry requirements. See photo 42.

Photo No. 42  
Wet riser conditions with manway visible

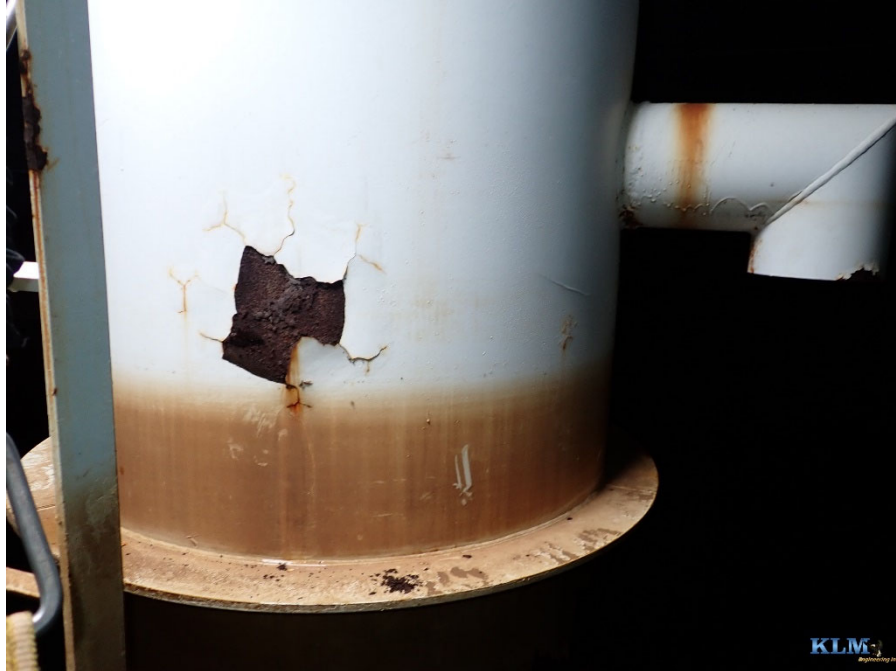
Photo No. 15  
Drywell tube with overflow pipe inlet visible  
Advanced corrosion visible

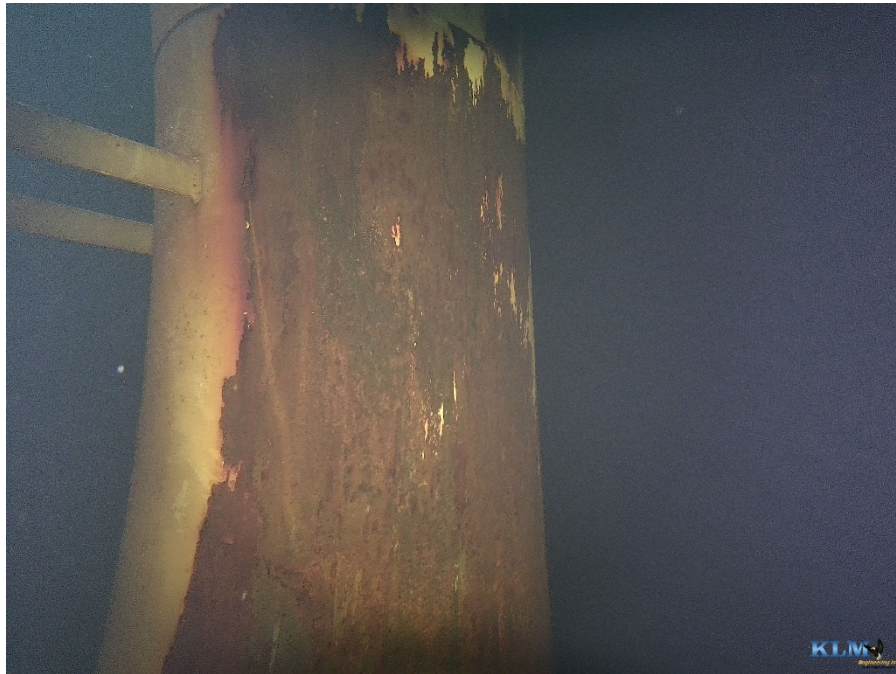
Photo No. 19  
Conditions of coating failure on drywell tube
